Corcoran Farms Business Park Environmental Assessment Worksheet Notice of Decision

Draft Environmental Assessment Worksheet

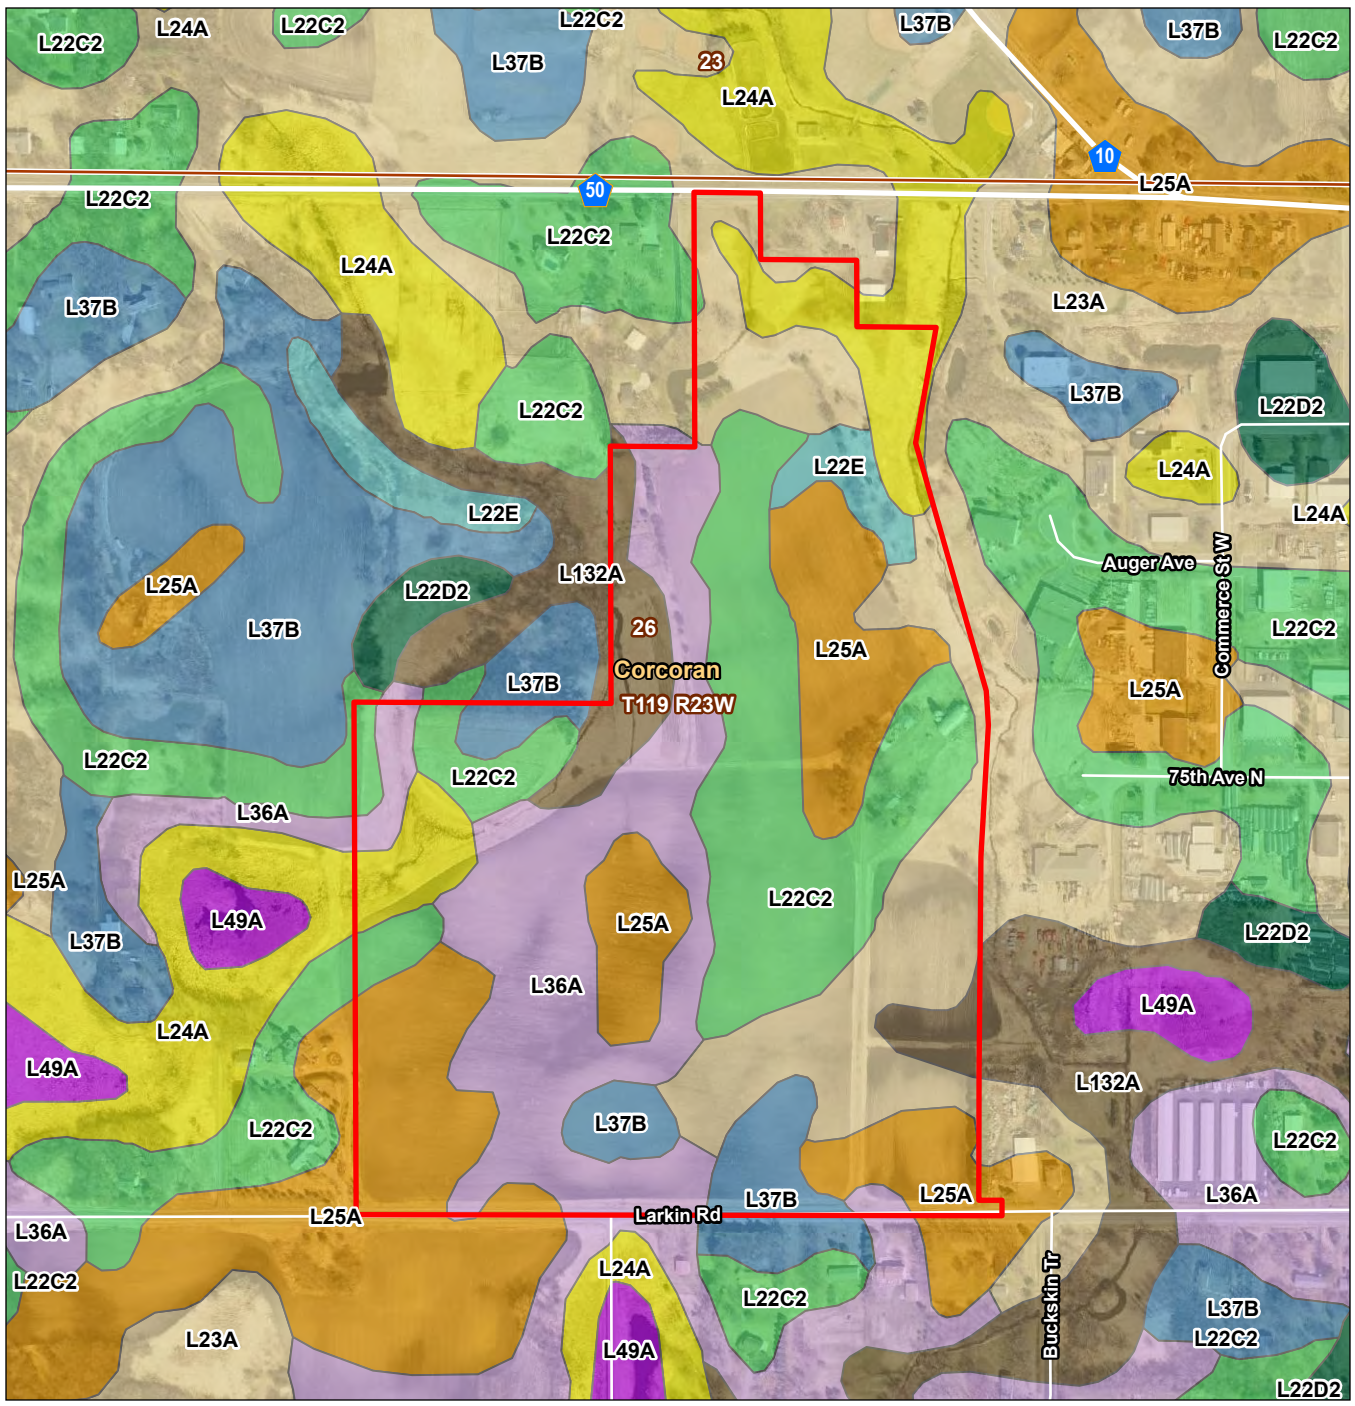
FIGURE 5

- Project Area
- Mapunit Symbol, Mapunit Name
- L132A, Hamel-Glencoe complex, 0 to 2 percent slopes
- L22C2, Lester loam, 6 to 10 percent slopes, moderately eroded
- L22D2, Lester loam, 10 to 16 percent slopes, moderately eroded
- L22E, Lester loam, 10 to 22 percent slopes
- L23A, Cordova loam, 0 to 2 percent slopes
- L24A, Glencoe clay loam, 0 to 1 percent slopes
- L25A, Le Sueur loam, 1 to 3 percent slopes
- L36A, Hamel, overwash-Hamel complex, 0 to 3 percent slopes
- L37B, Angus loam, 2 to 6 percent slopes
- L49A, Klossner soils, depressional, 0 to 1 percent slopes

According to the Natural Resource Conservation Service (NRCS) Web Soil Survey, the Project Area is comprised of eight soil types. Soil within the Project Area is associated mainly with moraines and hillslopes. The soil types include Lester loam (ground moraines and hillslopes; well drained), Cordova loam (drainageways on moraines, poorly drained), Glencoe clay loam (depressions, very poorly drained), Le Sueur loam (hillslopes and ground moraines; somewhat poorly drained), Hamel, overwash-Hamel complex (ground moraines, somewhat poorly drained), Angus loam (hillslopes and ground moraines; well drained), and Hamel-Glencoe complex (ground moraines, poorly drained). Figure 5, Appendix A identifies soils classifications within and in the vicinity of the Project Area.

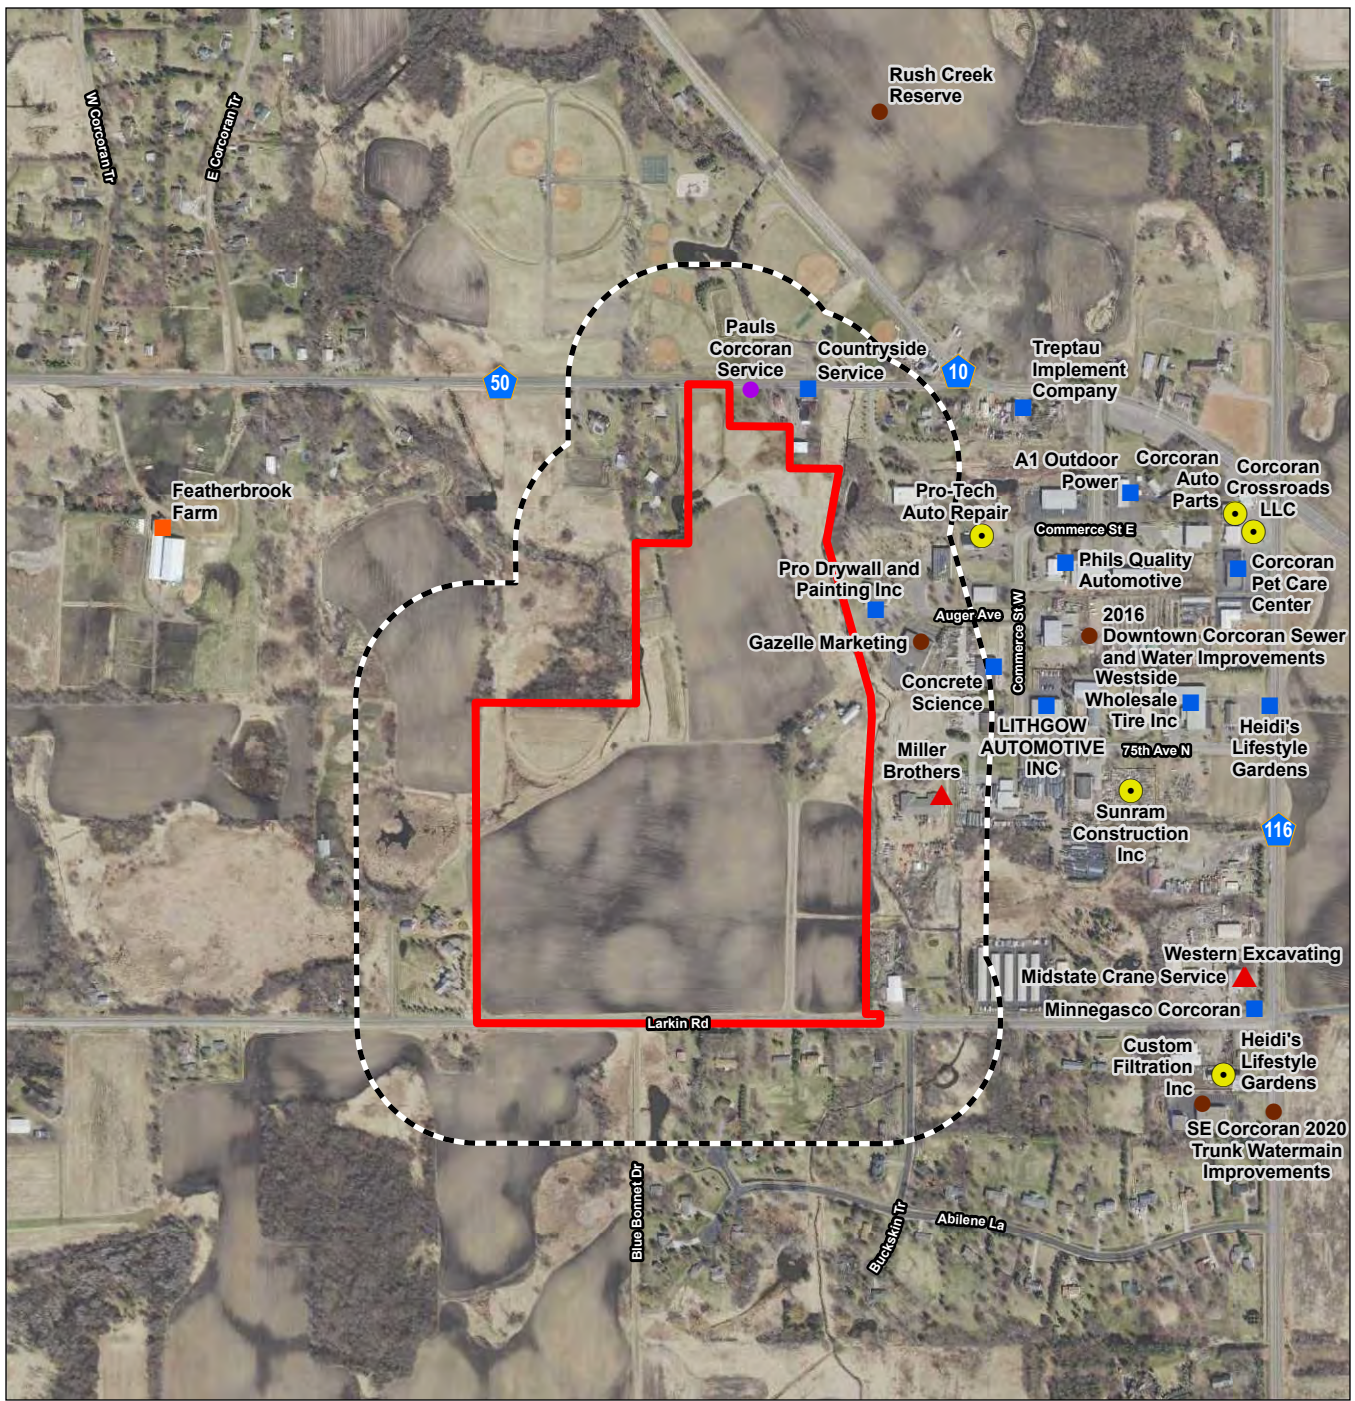
FIGURE 8

- Legend**
- Project Area
 - 500 ft Buffer
- MPCA Sites**
- Program Name**
- Multiple Programs
 - Feedlots
 - Hazardous Waste
 - Investigation and Cleanup
 - Stormwater
 - ▲ Tanks

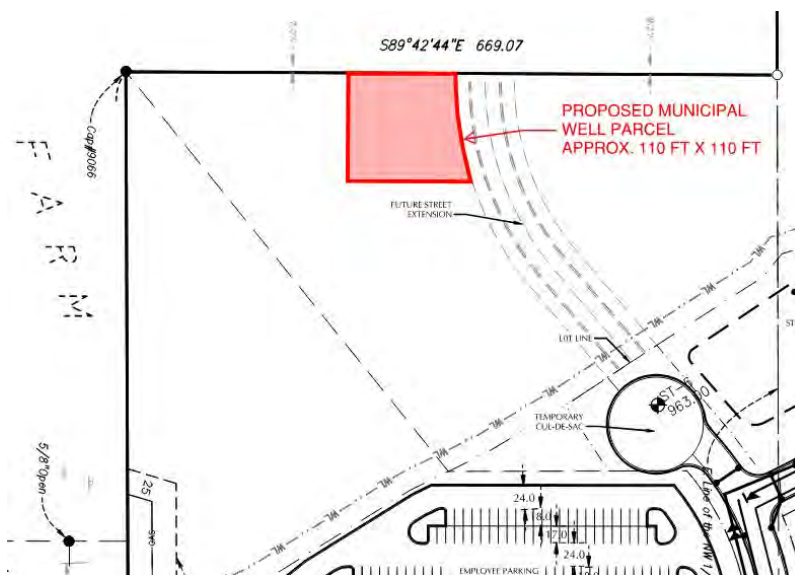
Proposed Municipal Well Parcel

It is noted that the City is requesting that the developer provide a parcel to the City for locating a future municipal well within Corcoran Farms Business Park (approximately 110 by 110 feet in size). Also, as discussed in the SE Corcoran water supply analysis draft report (Stantec draft report dated April 5, 2022), this may be a good location for one of the three initial test wells recommended for long-term supply within SE Corcoran. Figure 1 shows the location of the proposed municipal well parcel within the development.

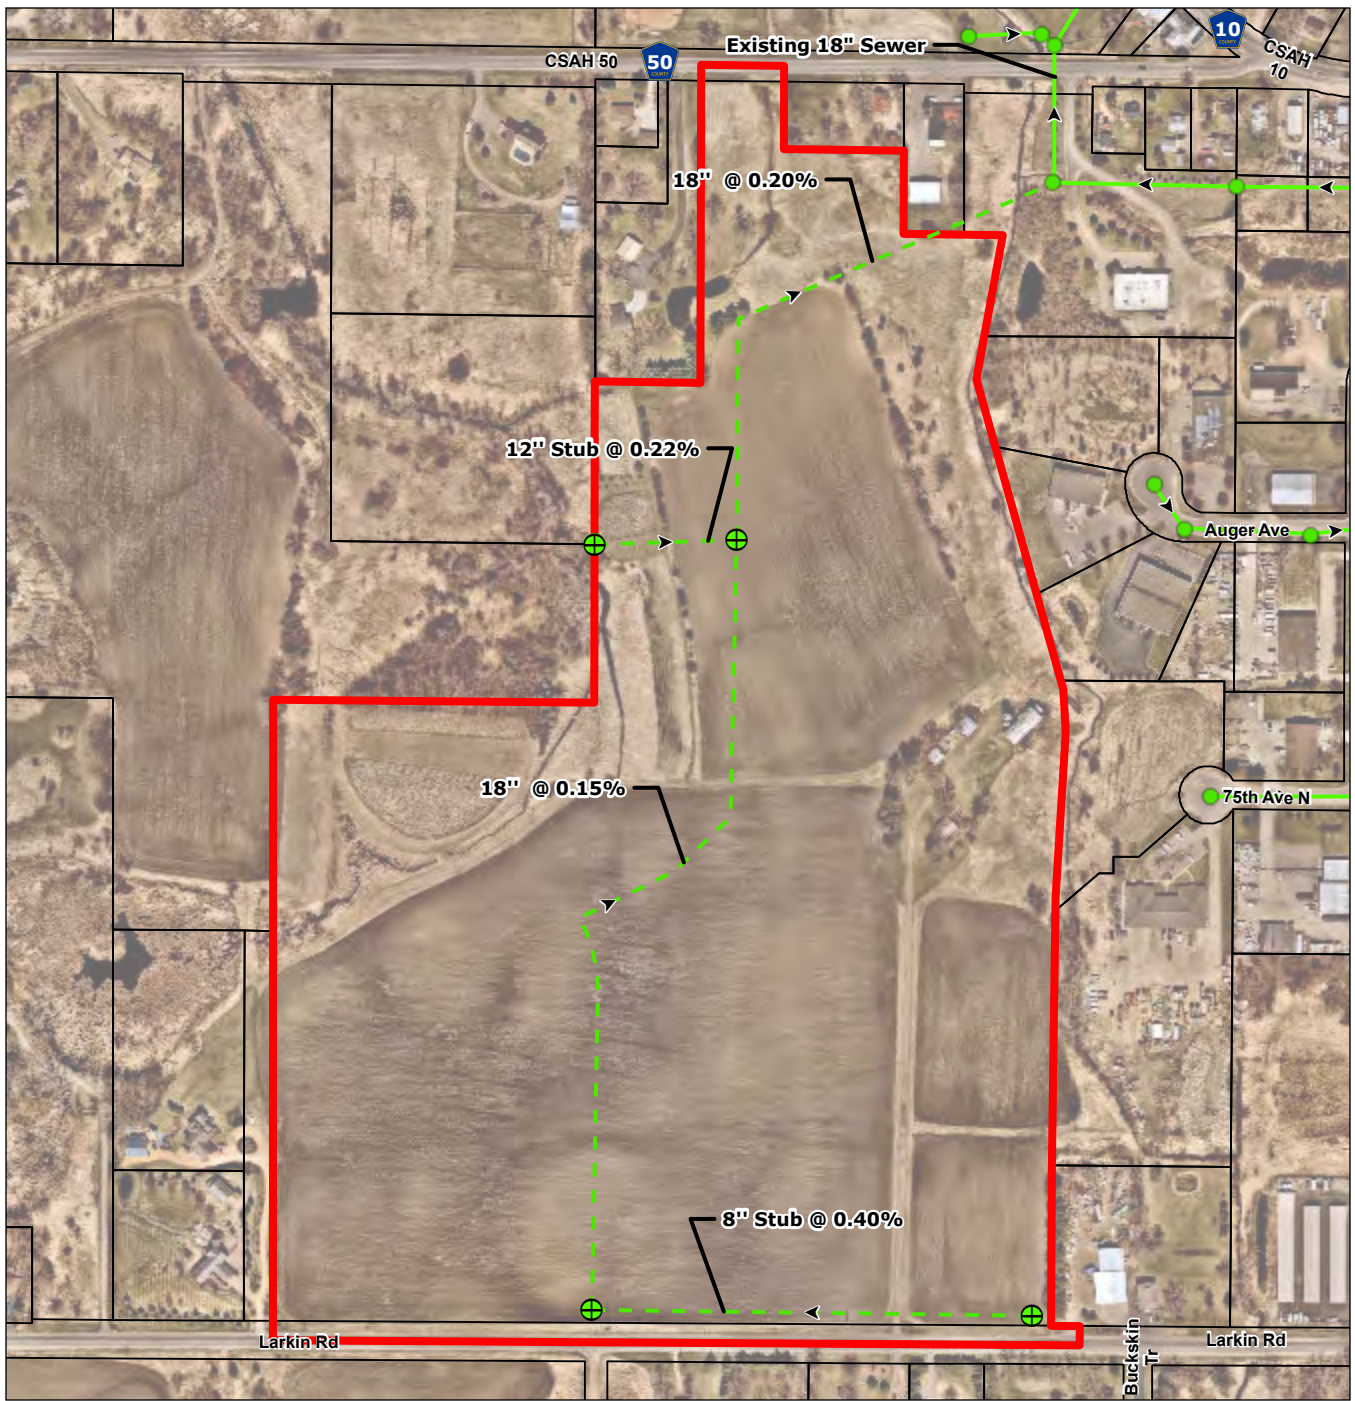
- Legend**
- Project Area
 - County Parcels
 - Existing Sewer
 - Existing Sanitary Manhole
 - - - - - Proposed Sewer Lines
 - ⊕ Proposed Manholes

In addition to the primary 18-inch trunk sewer, two sewer stubs must also be constructed in accordance with the Comprehensive Plan (see Figure 8). A 12-inch trunk sewer stub to the west parcel line must be constructed at approximately the same installation depth as the 18-inch sewer (i.e., as deep as possible, allowing for proper tie-in at the tee manhole). This will provide service to new developments located to the west of this development. An 8-inch sewer lateral to the southeast corner of the parcel must also be constructed to serve the parcels located further east (e.g., future connection of Larkin Road parcels). The sewer invert at the southeast corner should be 950.0 (approximately 20-foot depth), and a drop manhole may be utilized at the tie-in to the 18-inch trunk sewer, as appropriate.

- Developer to construct the 18-inch trunk sewer as shown on Figure 8.
- Developer to construct the 12-inch trunk sewer stub to the west and the 8-inch lateral sewer stub to the east as shown on Figure 1.

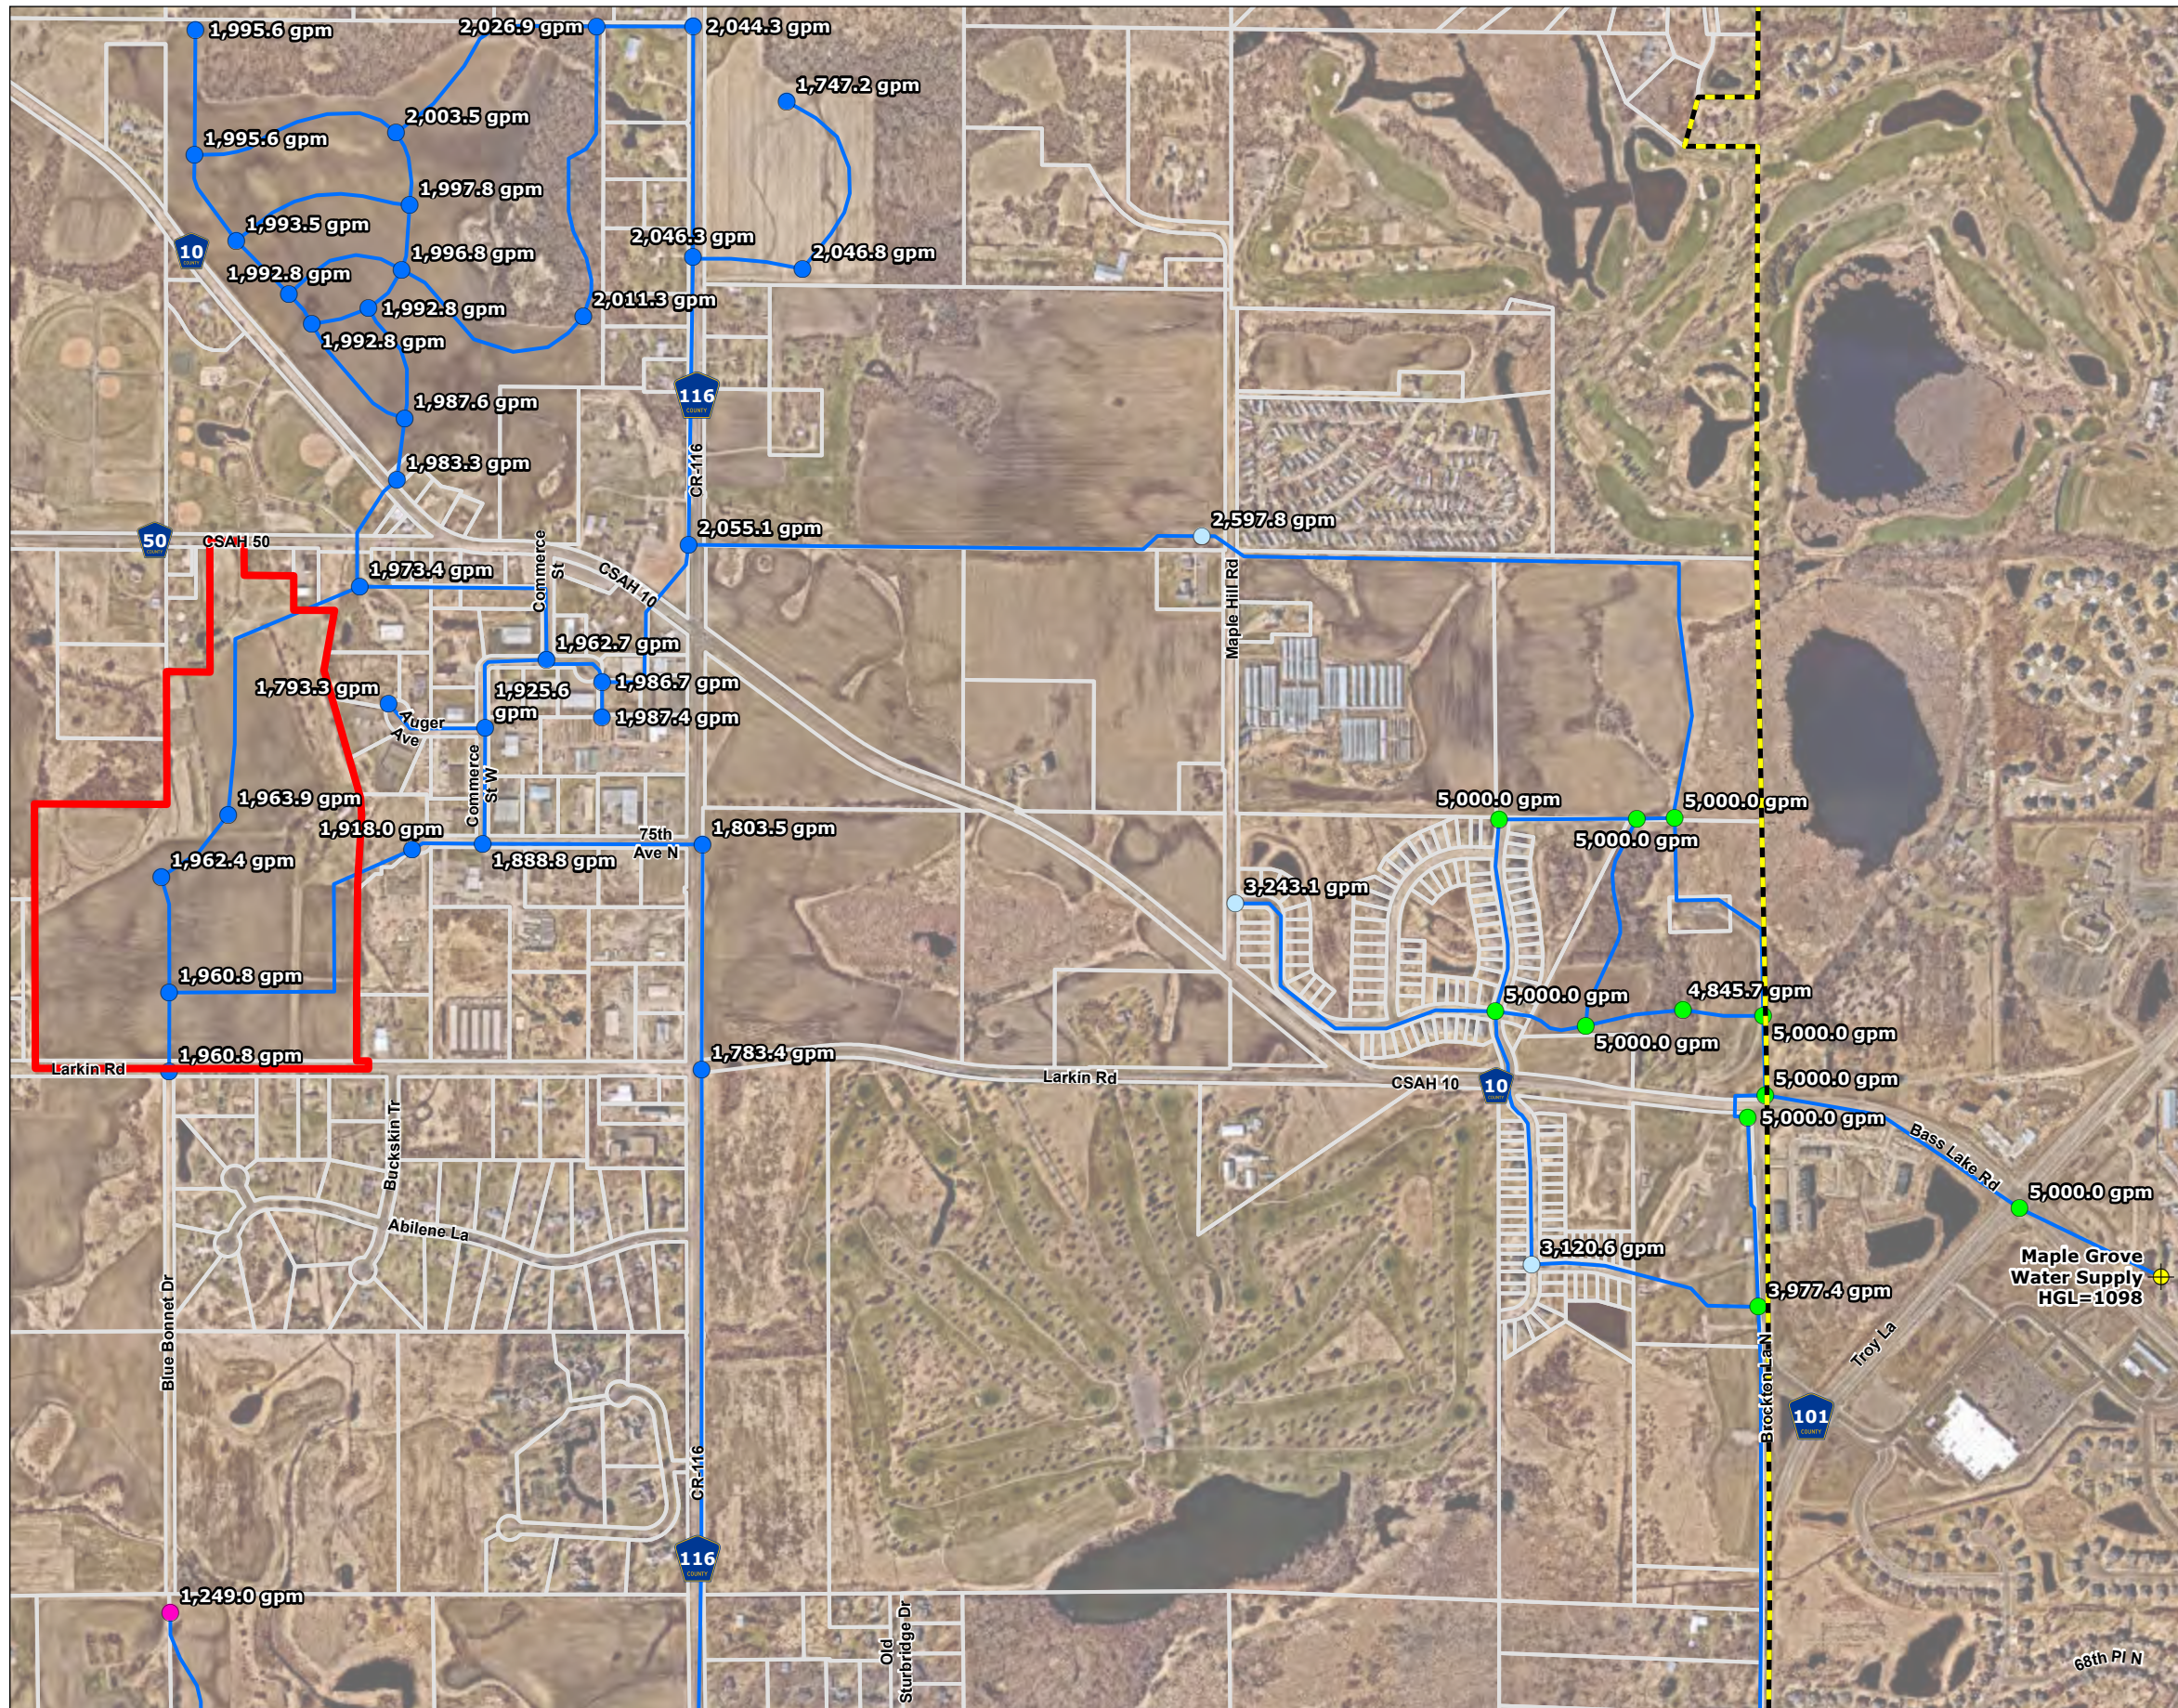
Figure No. **3**
 Title **Scenario 2b Fire Flow**
 Client/Project City of Corcoran 227704868
 Corcoran Farms Business Park
 Project Location Corcoran, Hennepin Co., MN Prepared by JCS on 2022-05-05

- Legend
- Municipal Boundary
 - Larkin Industrial Development
 - Parcels
 - + Water Supply
- Available Fire Flow
- >3,500 gpm
 - 2,500-3,500 gpm
 - 1,500-2,500 gpm
 - 500-1,500 gpm
 - Pipes

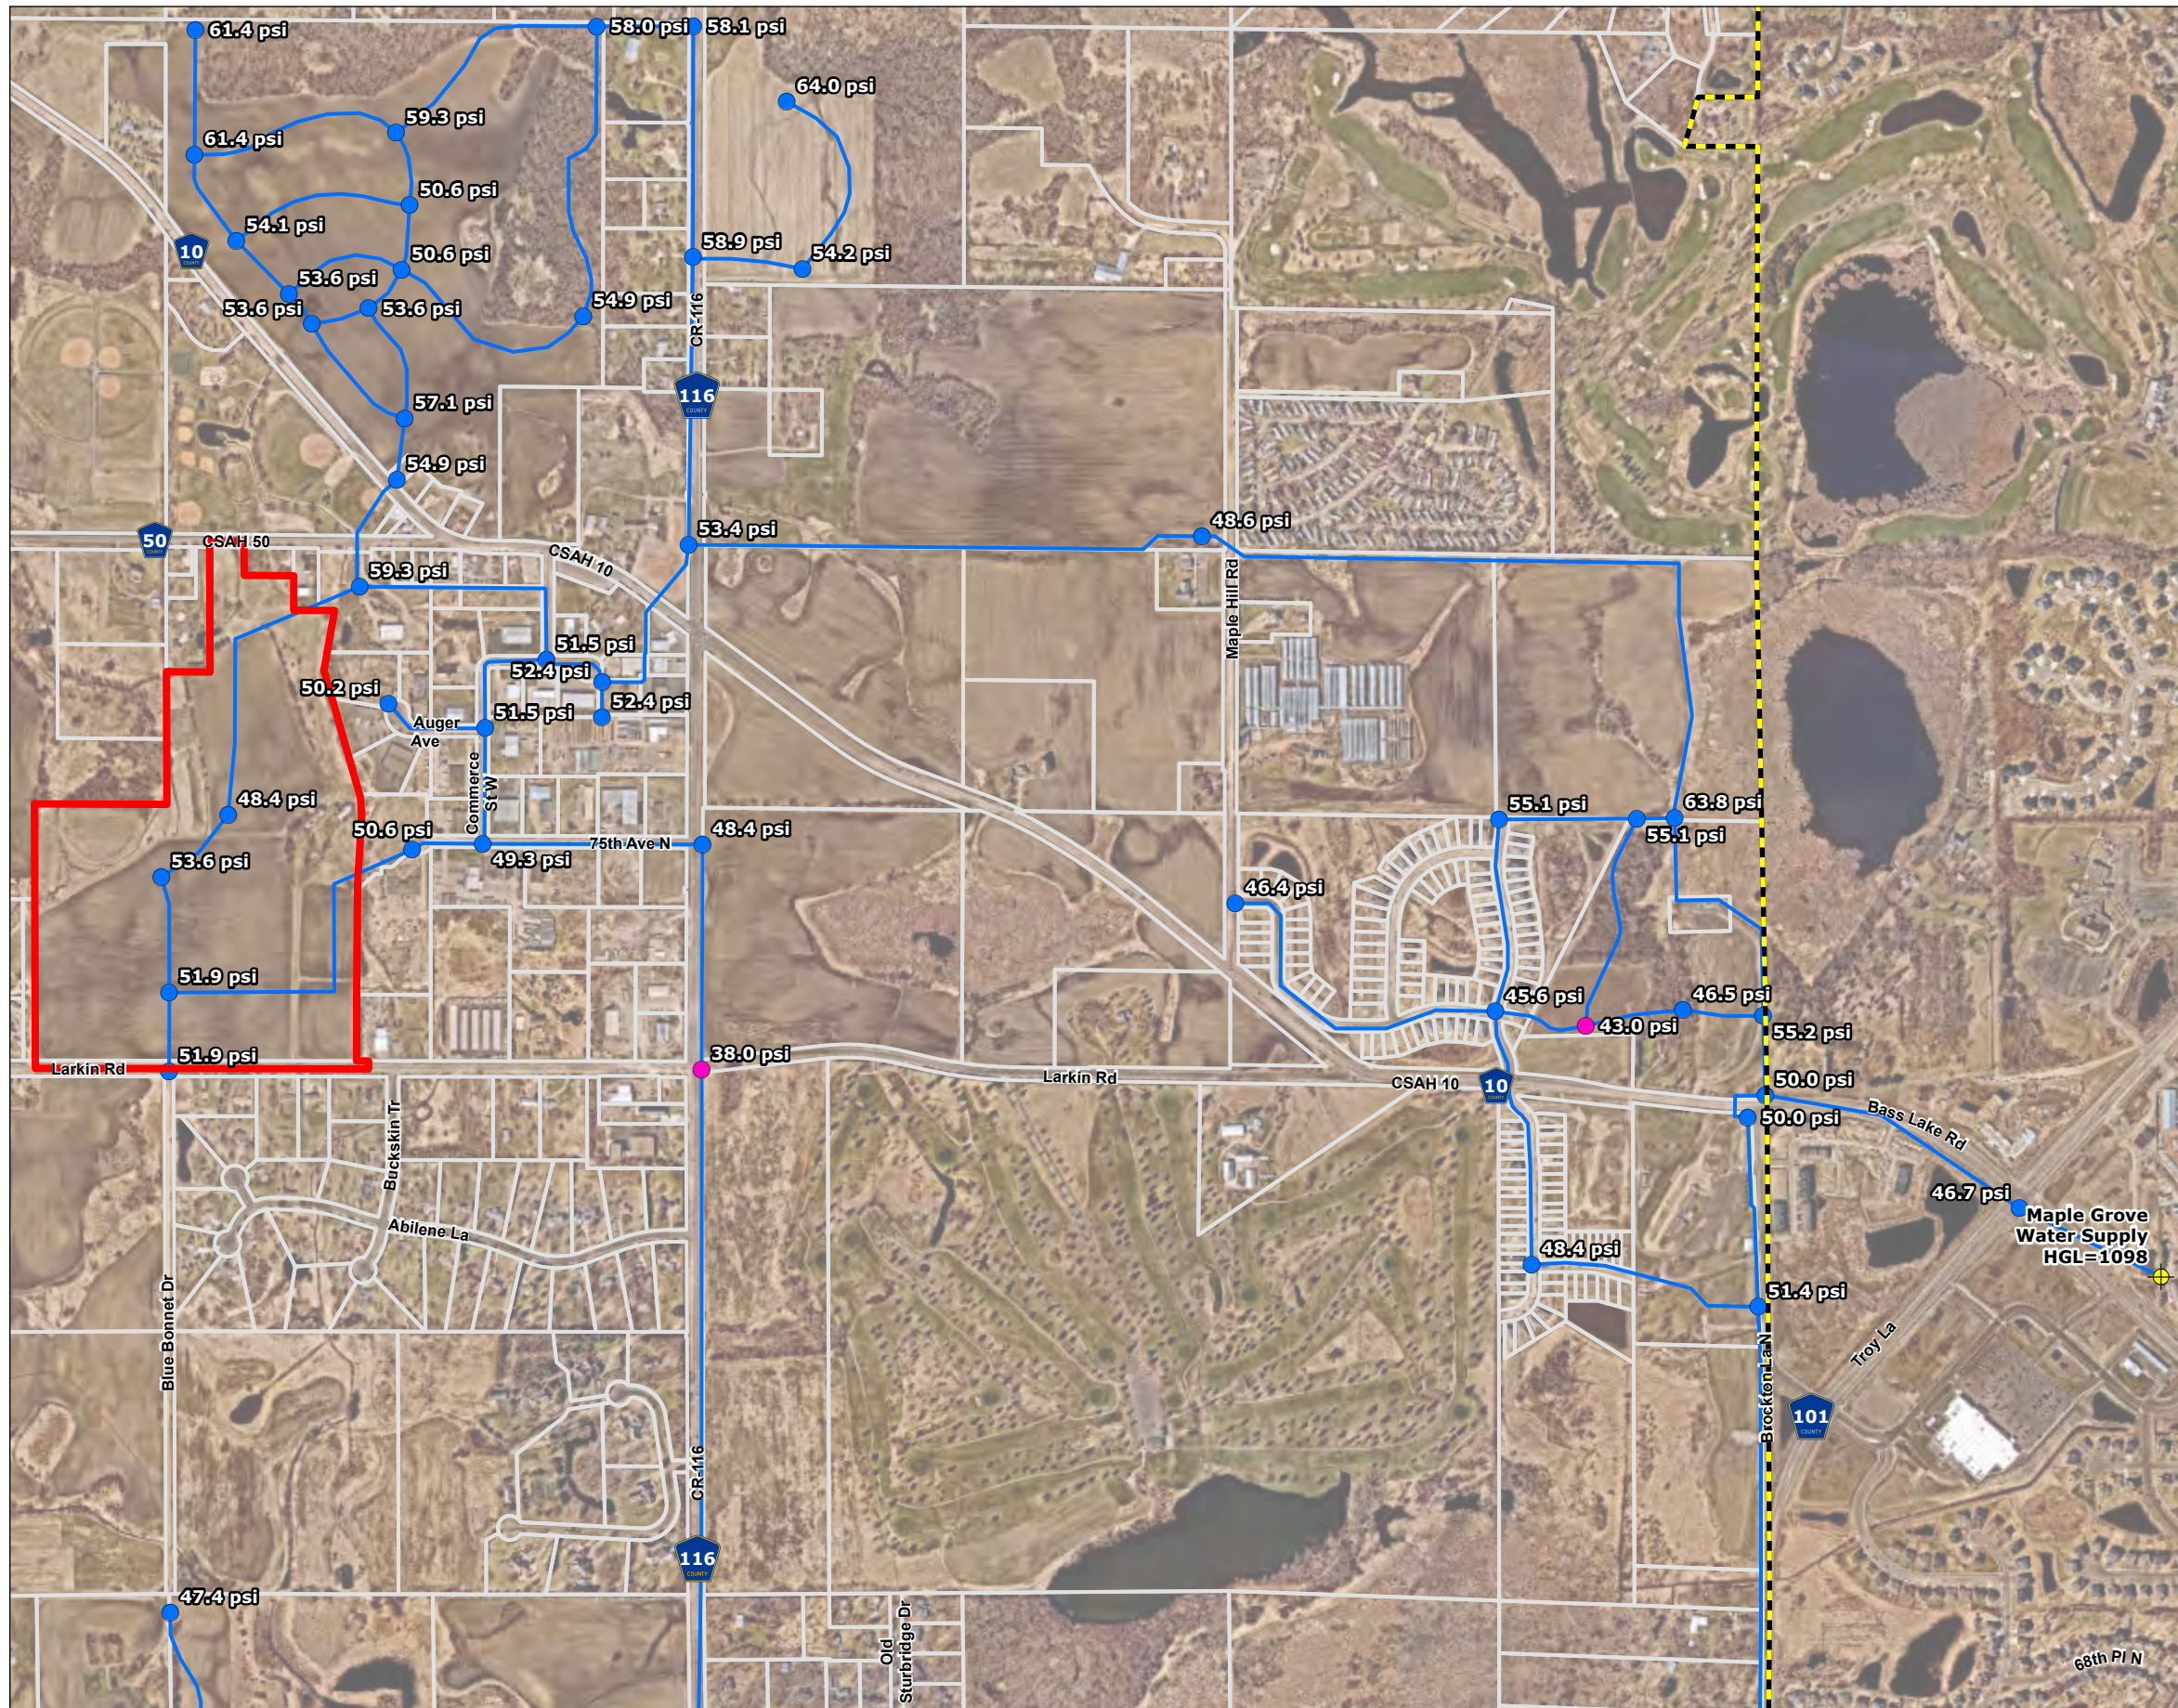
4

- 65-85 psi
- 45-65 psi
- 30-45 psi

Note: Pressures for Scenario 6b are similar

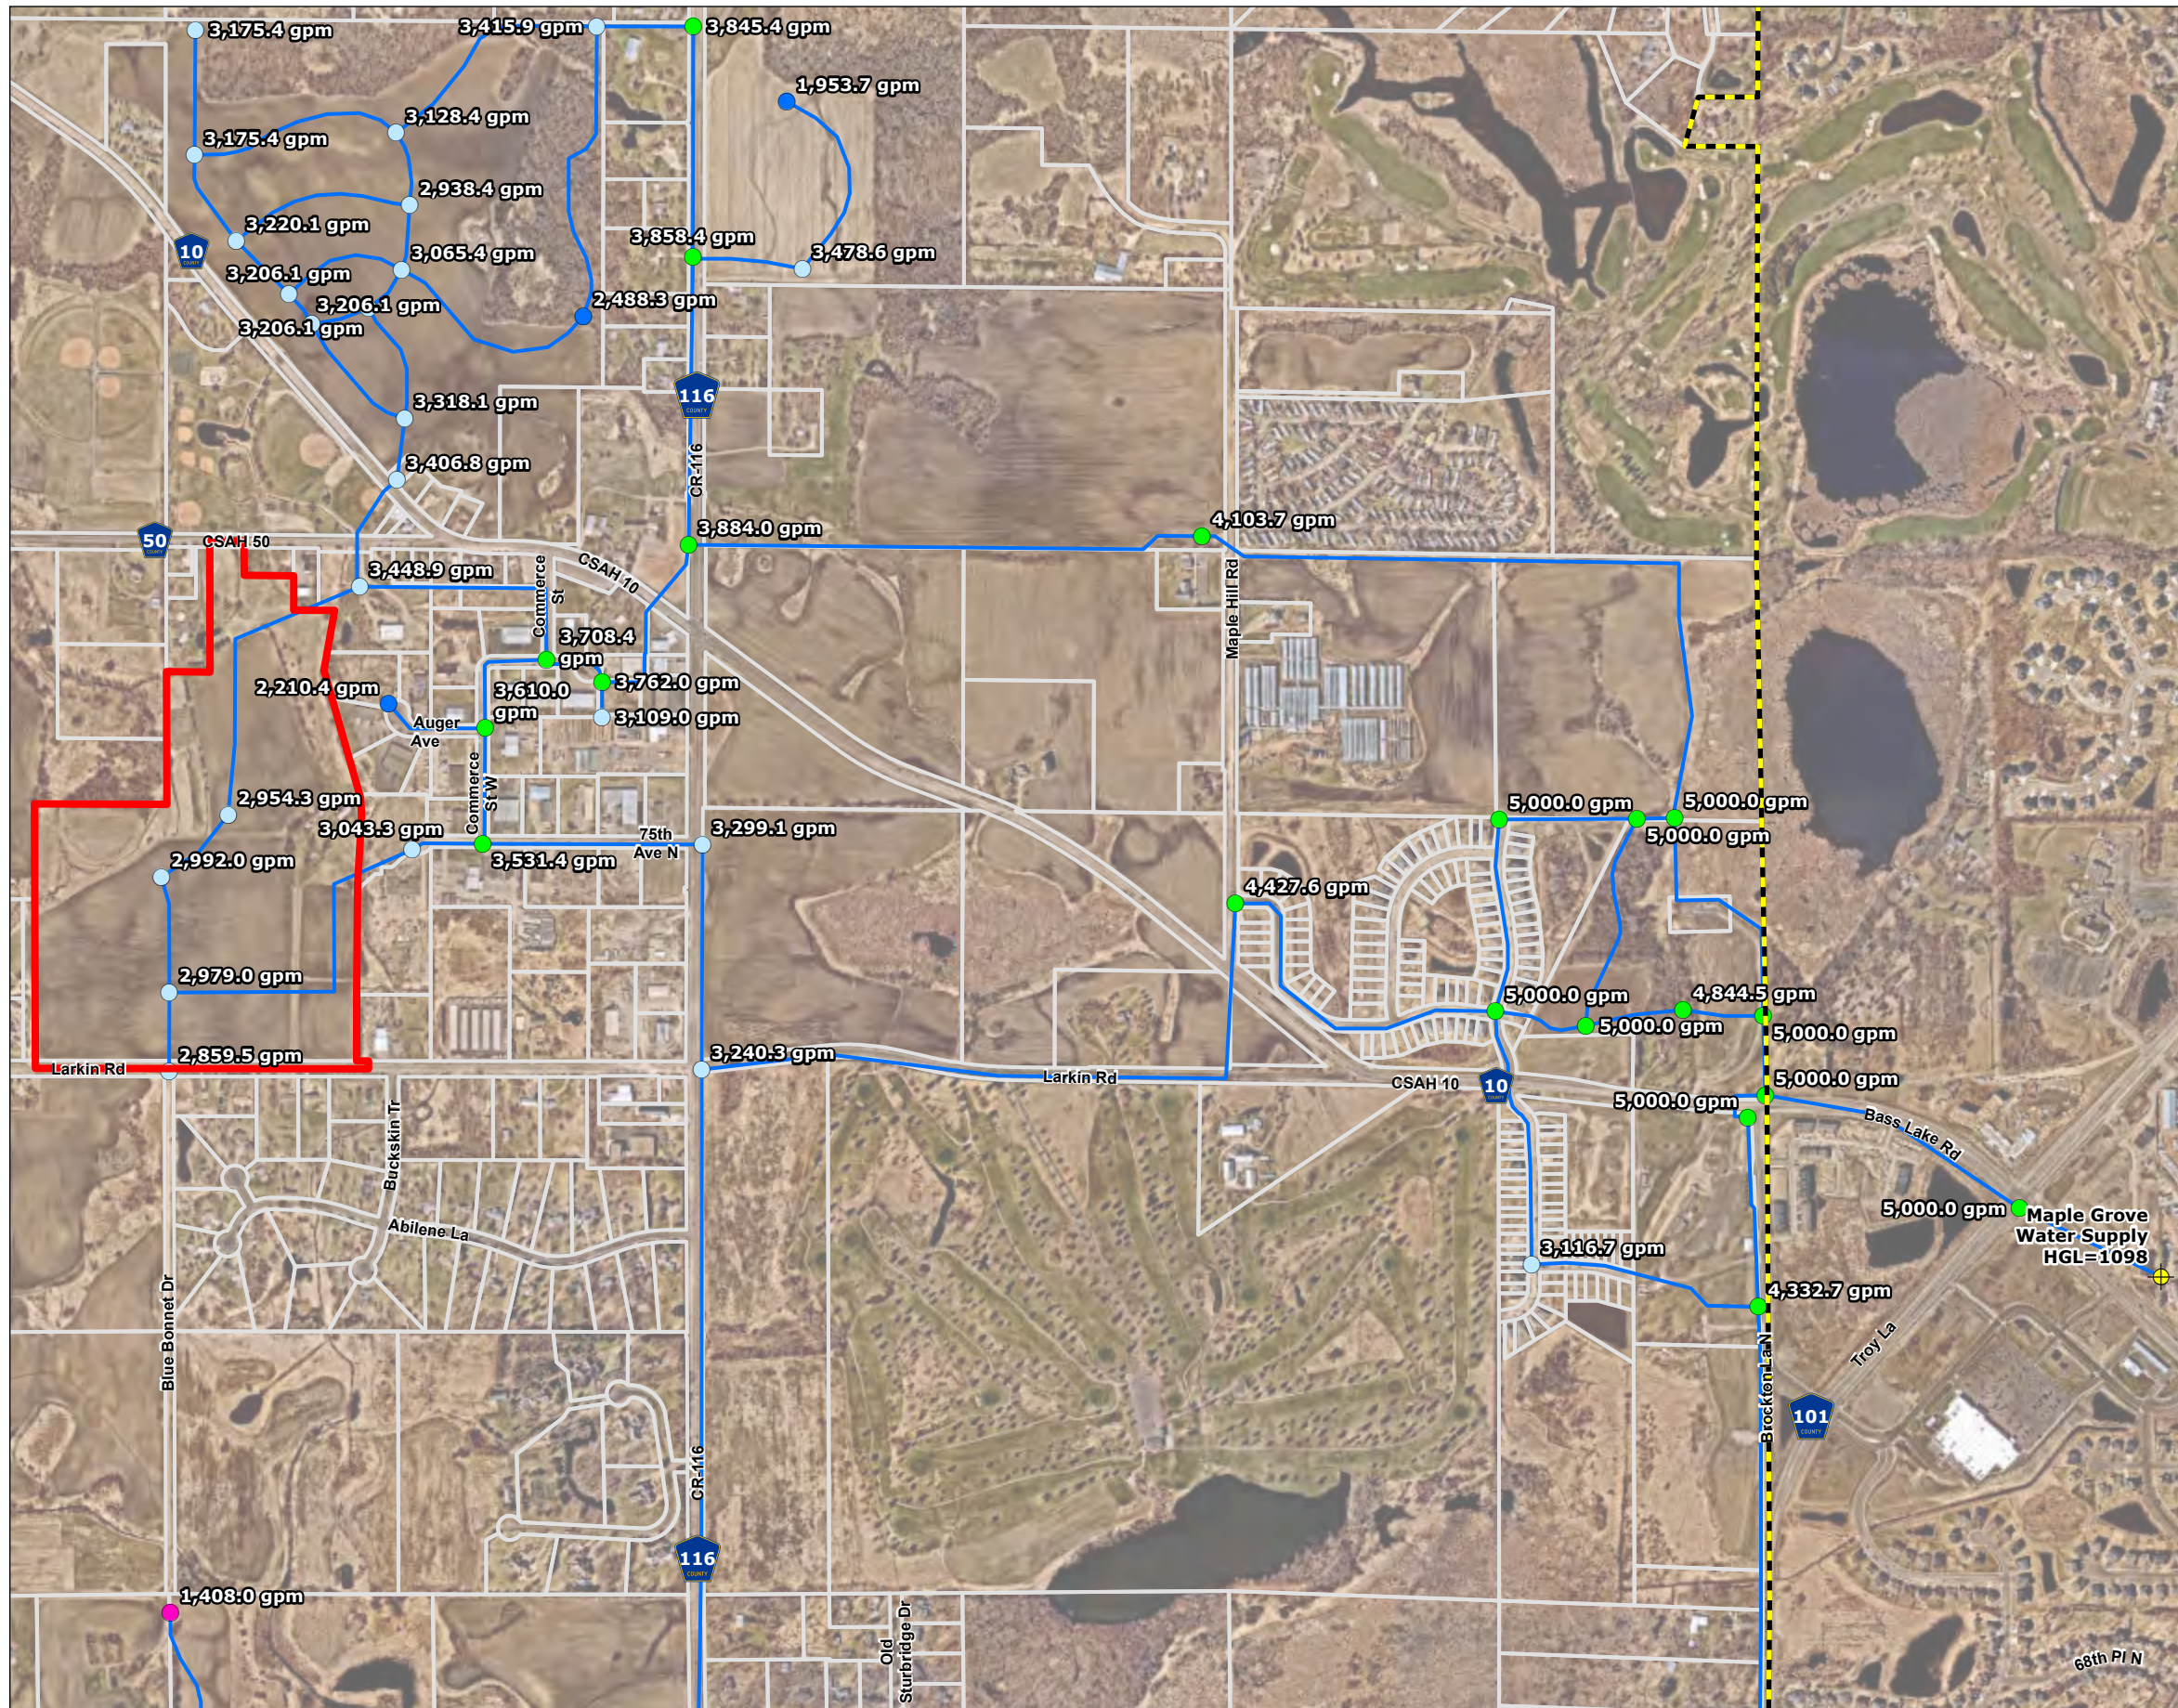
Figure No. **5**
 Title **Scenario 5b Fire Flow**
 Client/Project City of Corcoran, Corcoran Farms Business Park 227704888
 Project Location Corcoran, Hennepin Co., MN Prepared by JCS on 2022-05-05

- Legend
- Municipal Boundary
 - Larkin Industrial Development
 - Parcels
 - + Water Supply
- Available Fire Flow
- >3,500 gpm
 - 2,500-3,500 gpm
 - 1,500-2,500 gpm
 - 500-1,500 gpm
 - Pipes

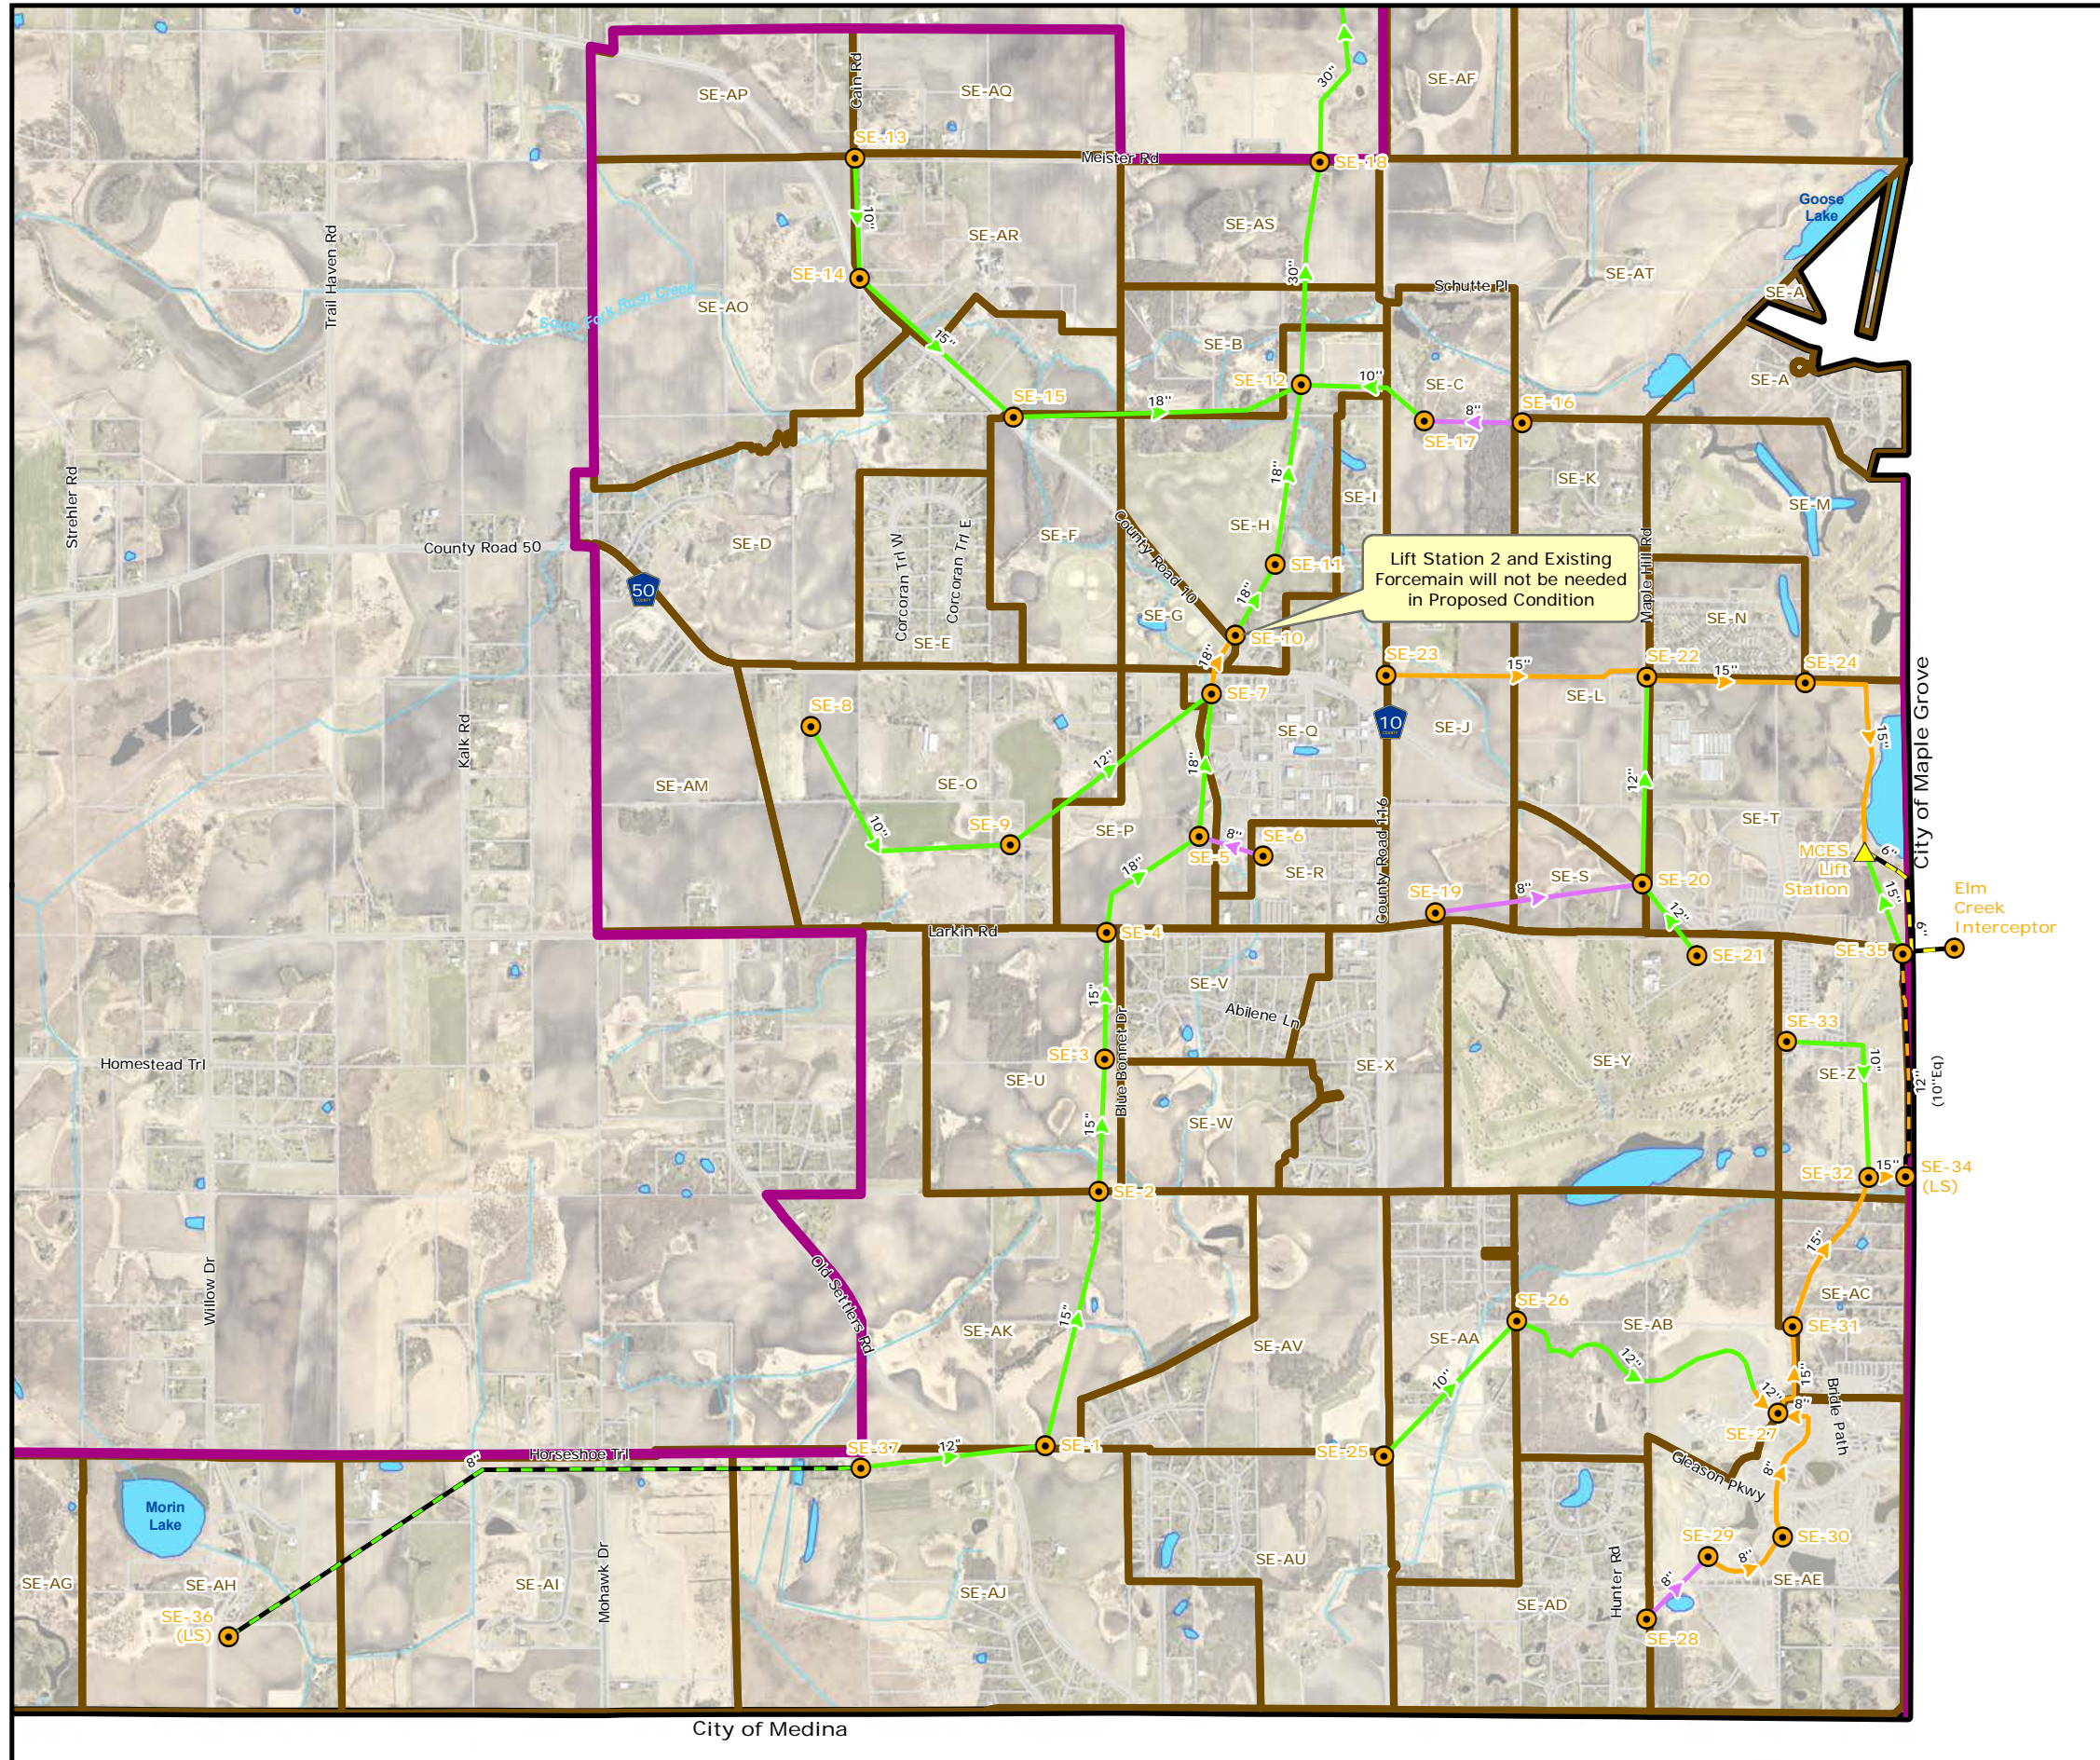
Map 7-3 Proposed Trunk Sanitary Sewer System - SE District

- Existing Gravity
- Proposed Gravity
- Proposed Gravity (Lateral)
- Existing Forcemain
- Proposed Forcemain
- Existing MCES Forcemain (Interim Size Shown)
- MCES Lift Station
- Sewer Node (LS) = Lift Station
- Sewer Subdistricts
- Municipal Boundary
- 2040 MUSA
- Parcel Boundaries
- Streams
- Lake/Open Water
