Corcoran Farms Business Park Environmental Assessment Worksheet Notice of Decision

Draft Environmental Assessment Worksheet

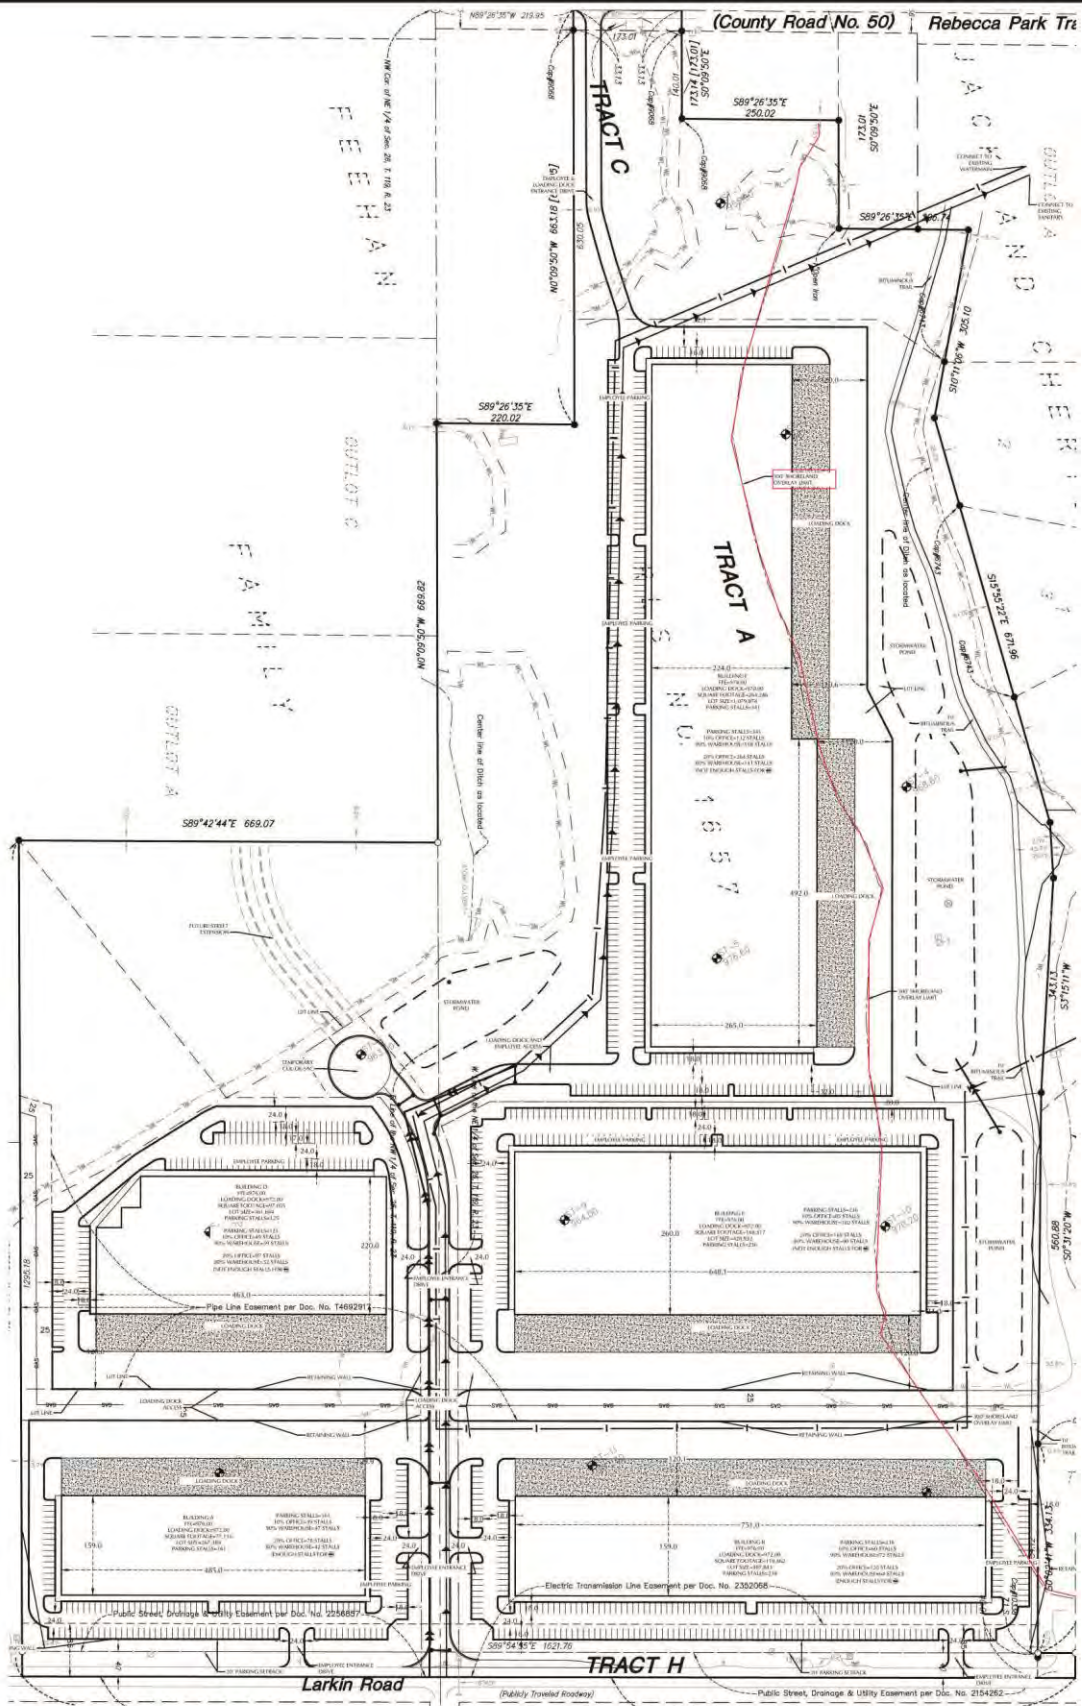
FIGURE 2
SITE PLAN

For purpose of this study, the development is expected to be completed in 2027. The proposed development plan is shown in Figure 2.

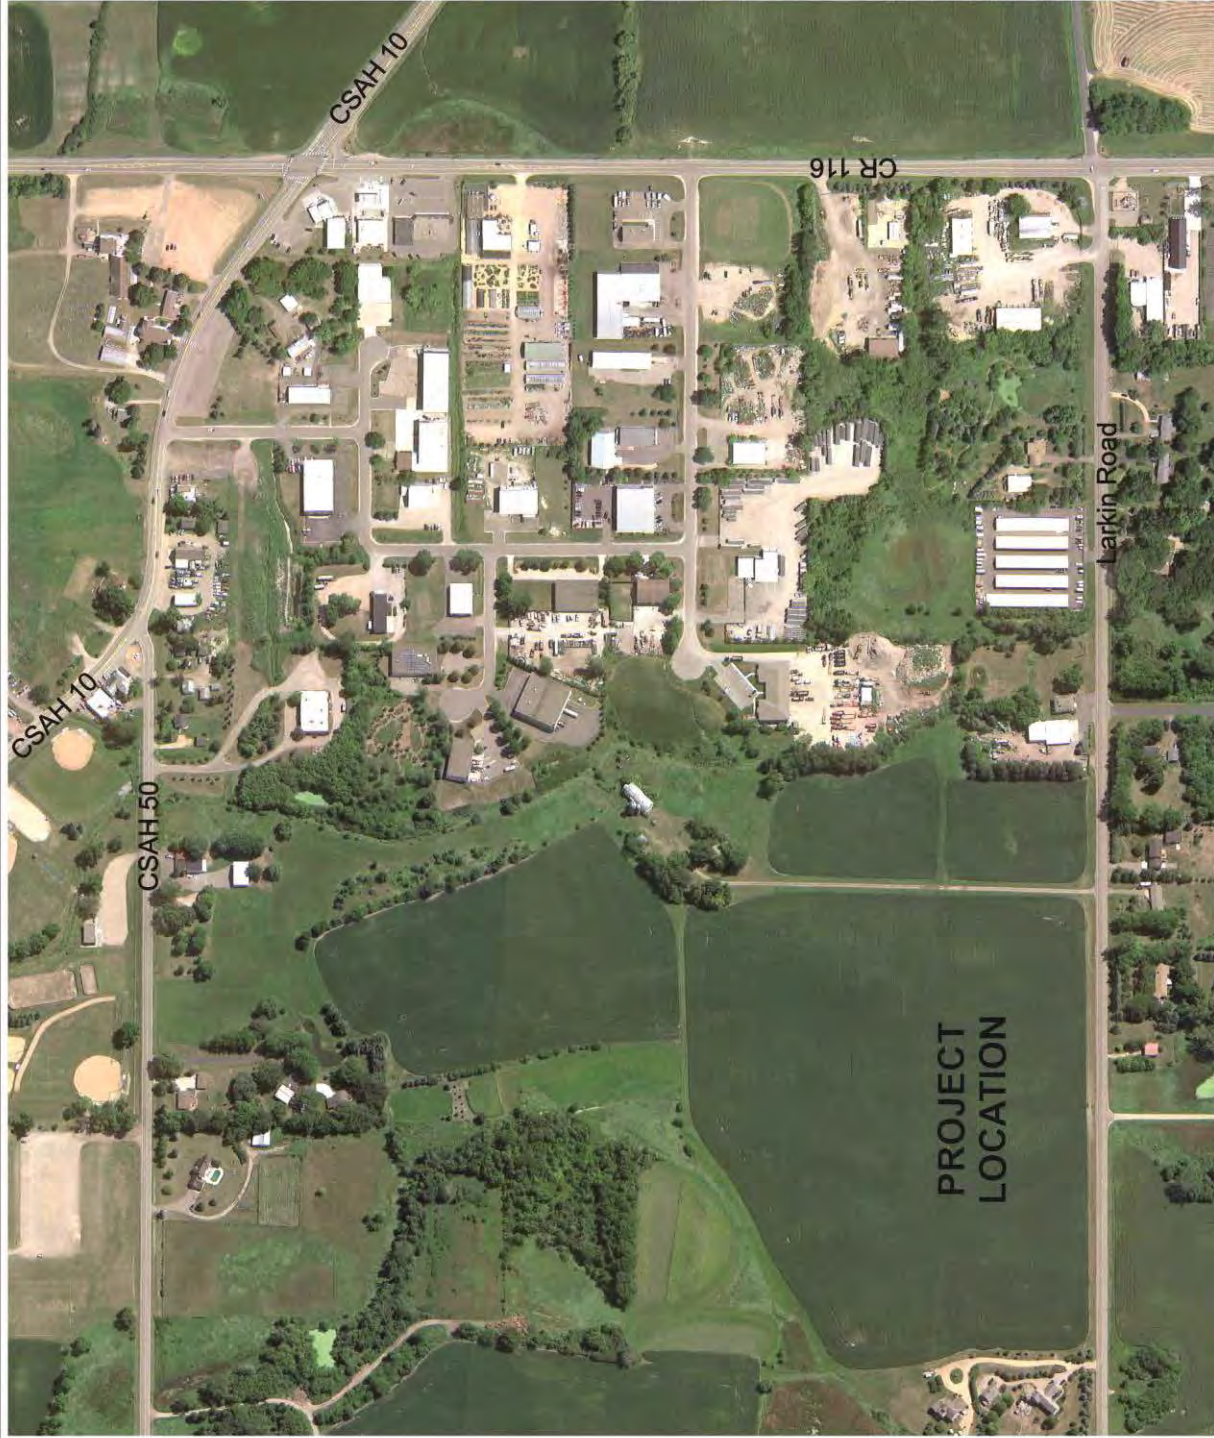
FIGURE 3
EXISTING CONDITIONS

Weekday traffic volume data was recorded at the existing intersections in March, 2022. Existing traffic volume data is presented later in this report.

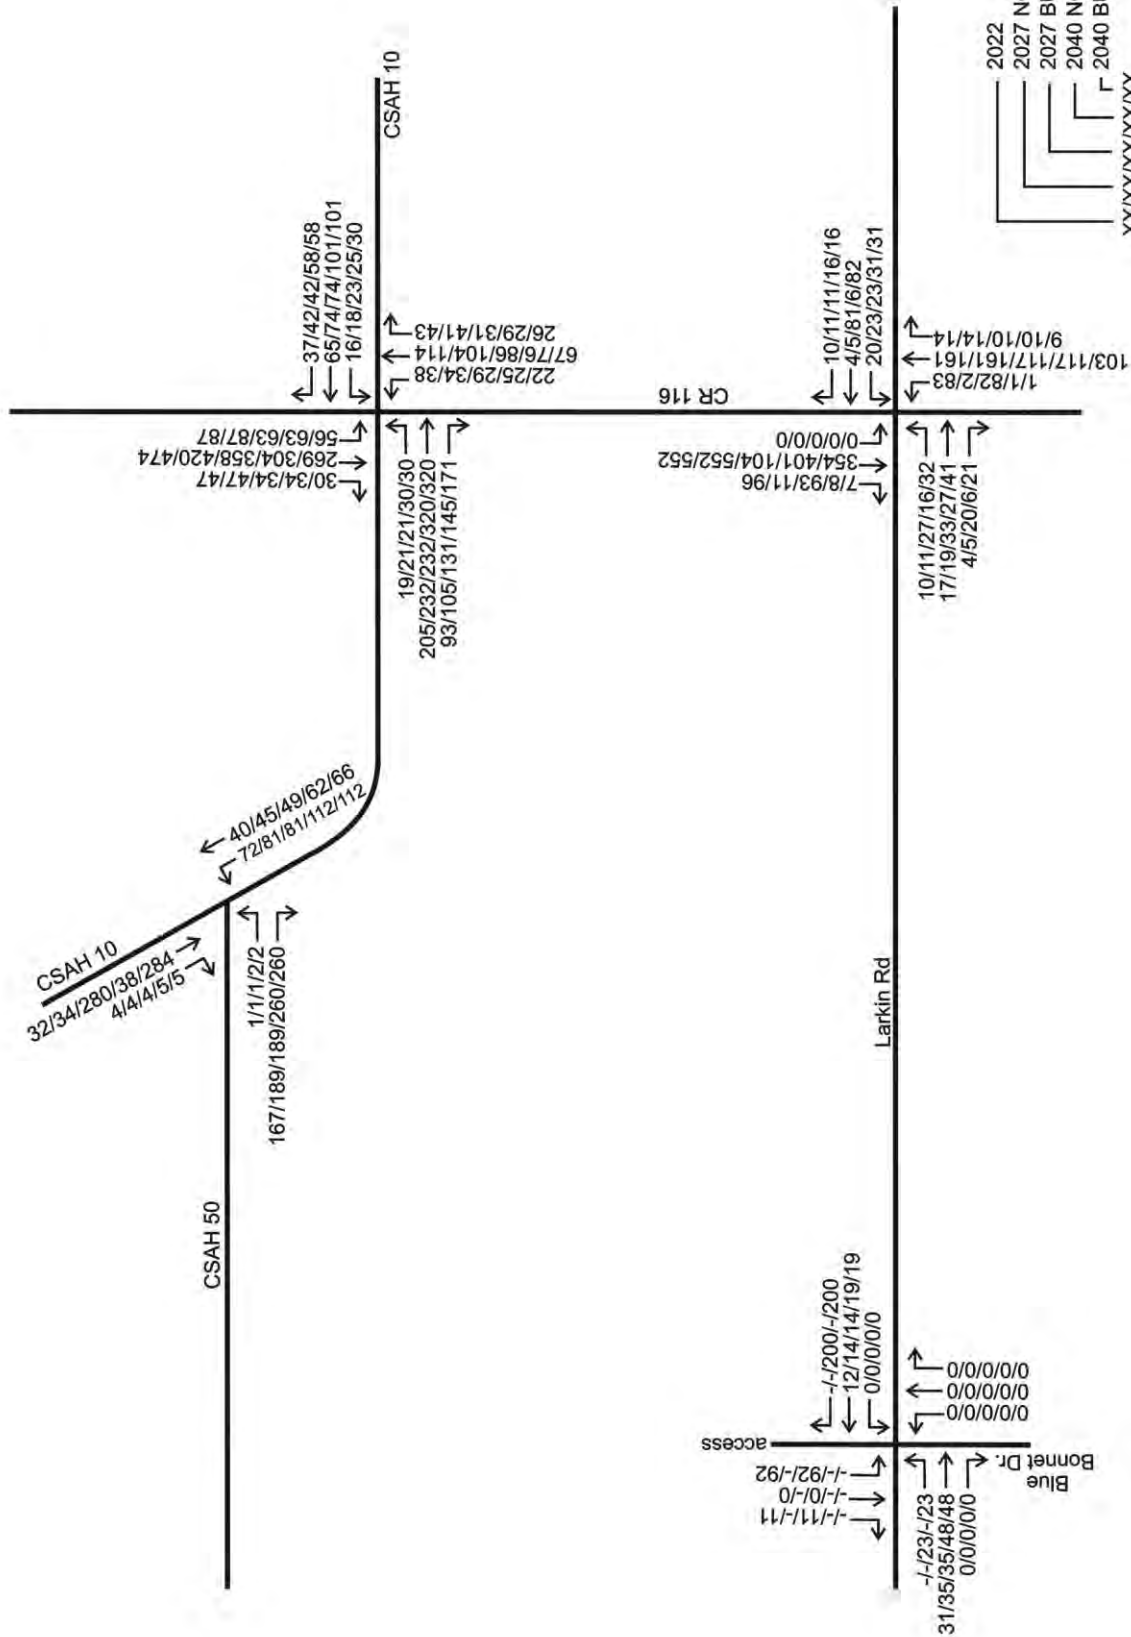
FIGURE 4
WEEKDAY AM PEAK HOUR
TRAFFIC VOLUMES

Development trips from Table 4-1 were assigned to the surrounding roadway network using the preceding trip distribution percentages. Traffic volumes were established for all the forecasting scenarios described earlier during the weekday a.m. and p.m. peak hours. The resultant peak hour volumes are shown in Figures 4 and 5.

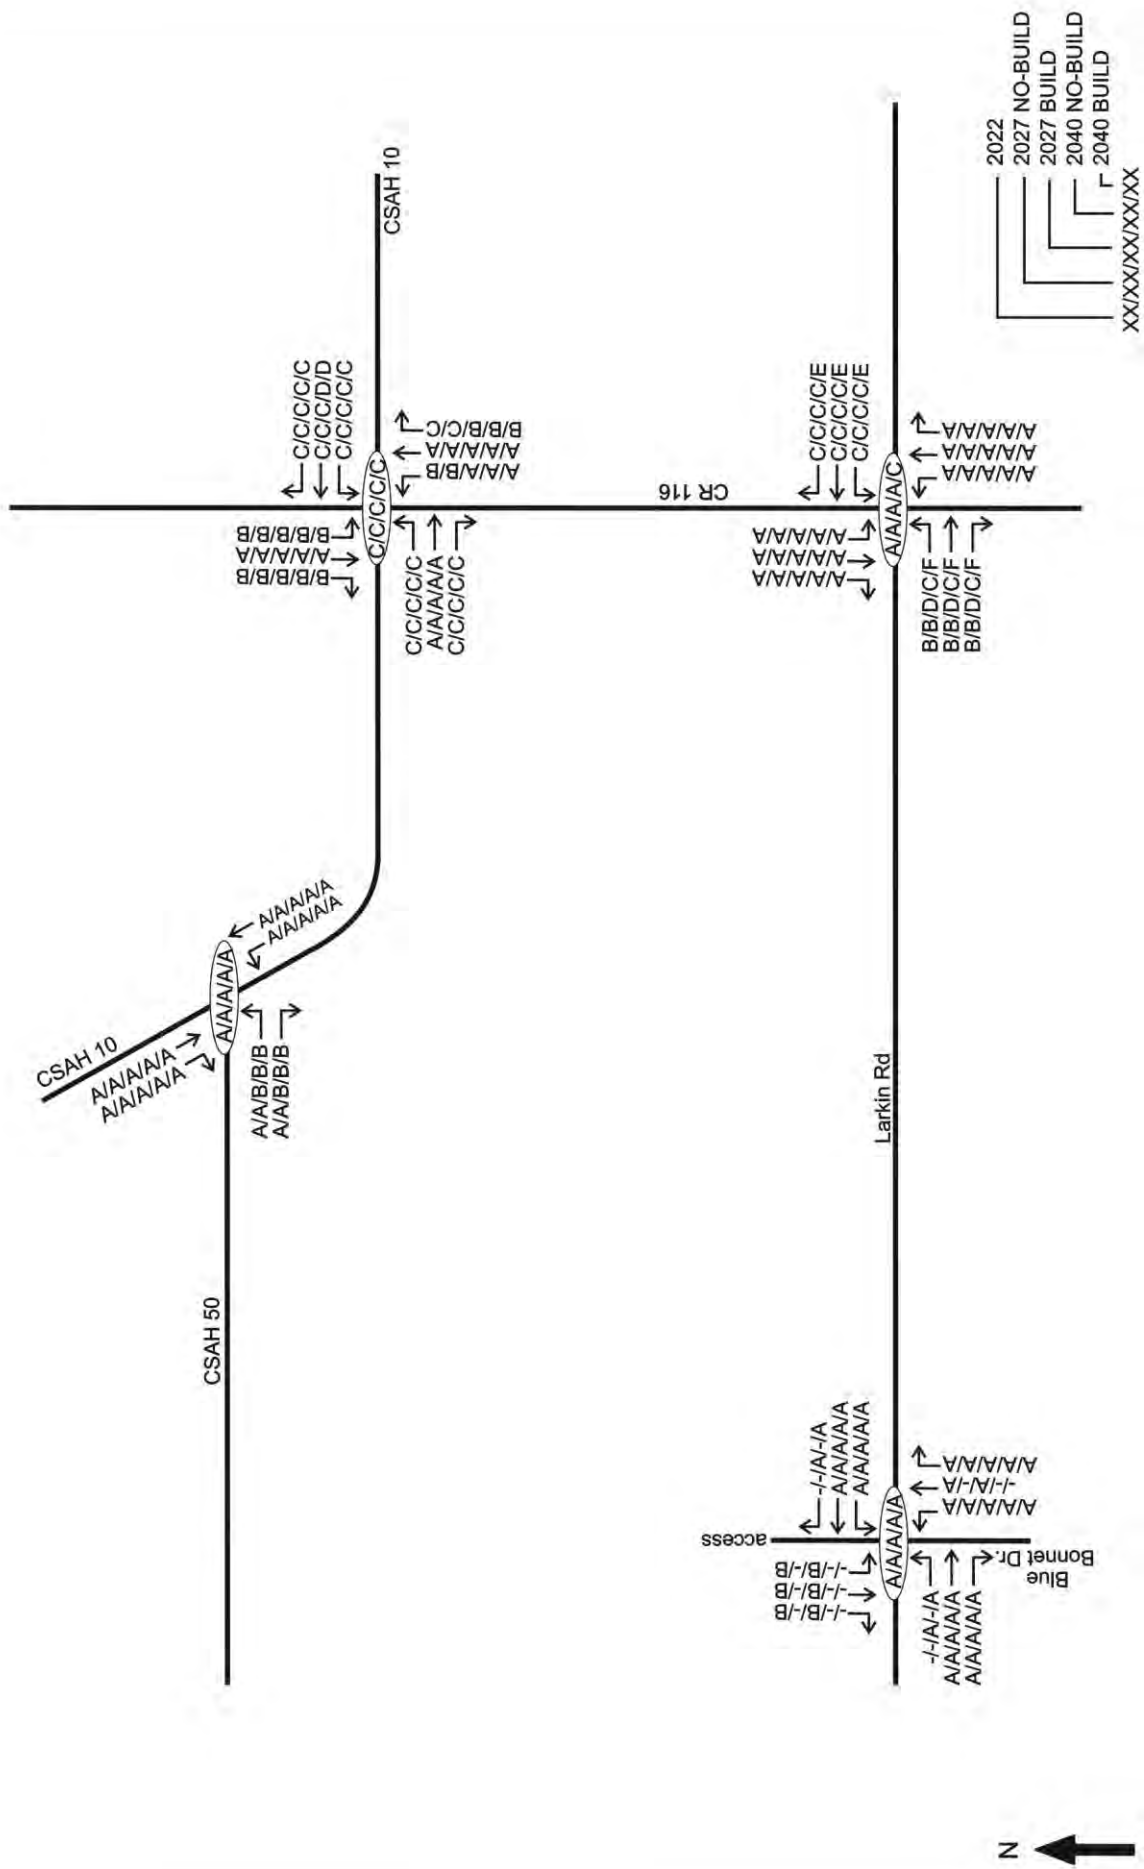
FIGURE 7
WEEKDAY PM PEAK HOUR
LEVEL OF SERVICE RESULTS

- CSAH 10/CR 116
 - Short term – No improvements needed.
 - Long term – No improvements needed.
- CSAH 10/CSAH 50
 - Short term – No improvements needed.
 - Long term – No improvements needed.
- CR 116/Larkin Road
 - Short term – Widen the eastbound and westbound approaches to accommodate a left turn lane and a through/right turn lane. Widen the northbound and southbound approaches to accommodate a left turn lane, through lane, and right turn lane.
 - Long term – Monitor traffic volumes to determine when signal control is warranted.
- Larkin Road/Blue Bonnet Drive/development access
 - Short term – Construct a westbound right turn lane.
 - Long term – No additional improvements needed.
